# Pre-drywall inspection Report

**Inspection Date:**  
08/02/2007

9876 Main Street , Pasco County, Fl

Site is at the Pre-drywall stage.

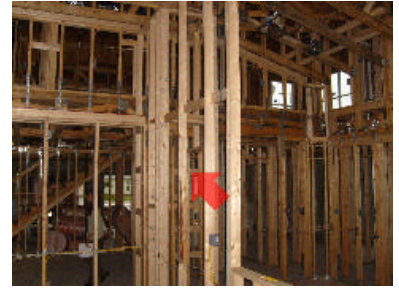
There appears to be missing fireblocking or firestopping at the tall wall between the family room and the kitchen. Check with builder as to whether it is required here.

The fourth stud to the left of the front window at the bonus room is bowed in. It should be checked to see if it can be straightened.

Accepted building practice dictates that fasteners for pressure preservative treated wood shall be of hot-dipped galvanized steel, stainless steel, silicon bronze or copper. This fasteners include bolts for bottom plates, nails holding furring strips to walls, and fasteners for electrical boxes and equipment.

Visible fasteners do not appear to meet this criteria. Check with builder as to whether fasteners used are in accordance with standards.

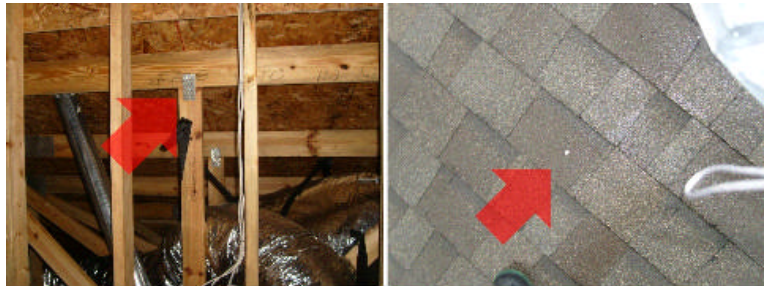
REPAIR: Nails/Fasteners are protruding from the roof surface at front slope and back slope. They should be repaired.  
A truss plate visible from the top of the stairs in the bonus room is loose.

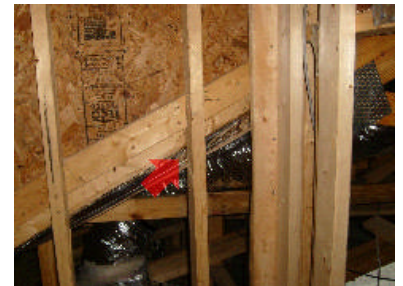
Visible water was present at the west wall of the bonus room bedroom along the roof wall junction. Flashing in this area should be checked for proper installation.
